STS-113 POST LAUNCH FILM REVIEW
KSC Photo/Video Analysis Team
26 November 2002

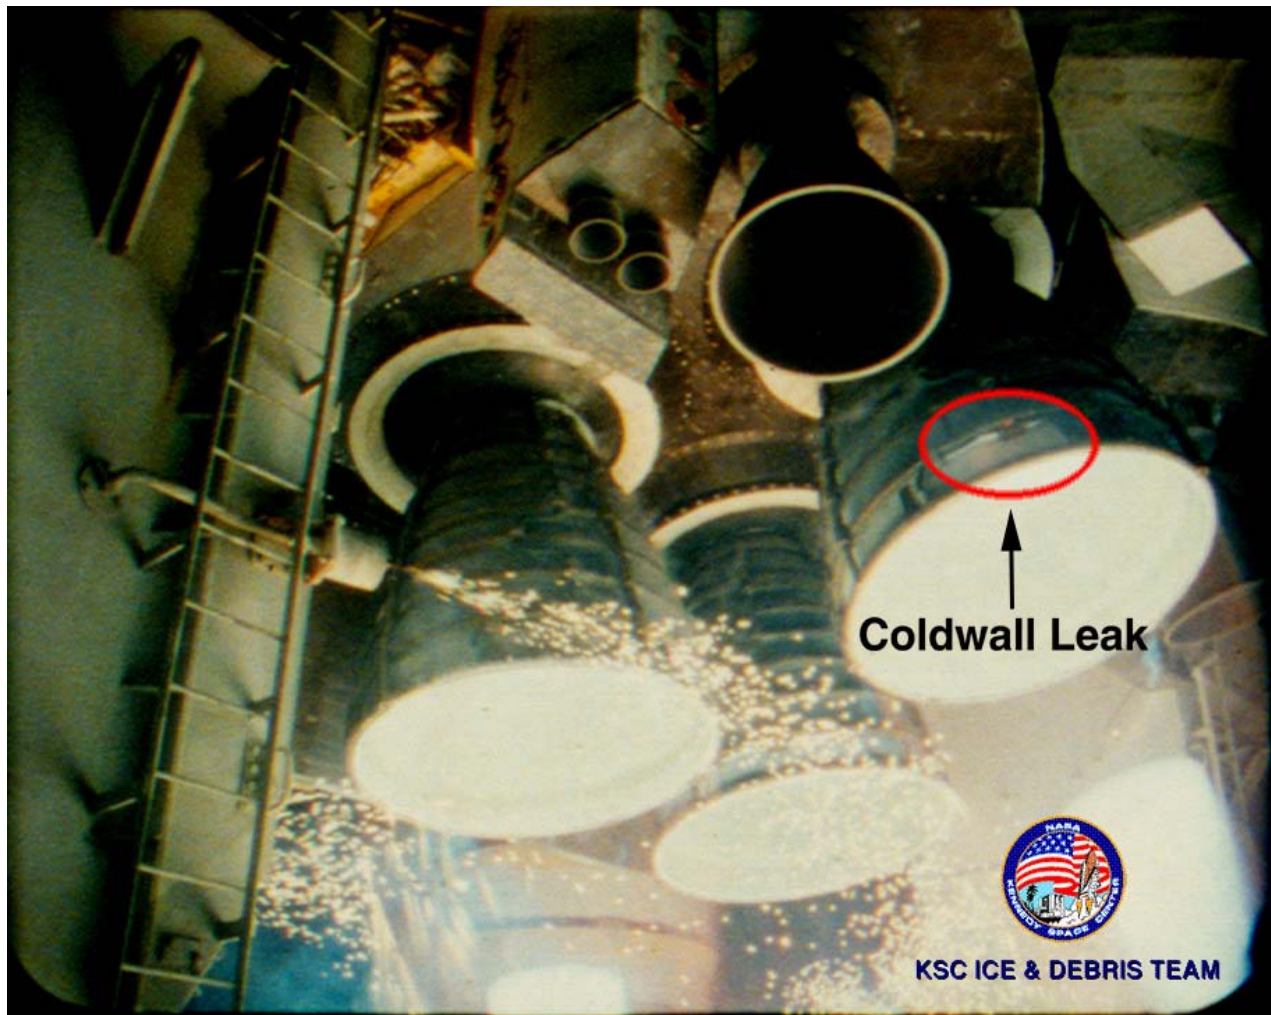
A cold wall leak was observed on SSME #1 (ME-2050). The leak was located at approximately the 10 o'clock position in between hat band #9 and the aft manifold. Clip of SSME start-up at following link: http://www-launchops.ksc.nasa.gov/msdinfo/reports/STS113_Coldwall.mpeg

Photo 1. SSME #1 Cold wall leak

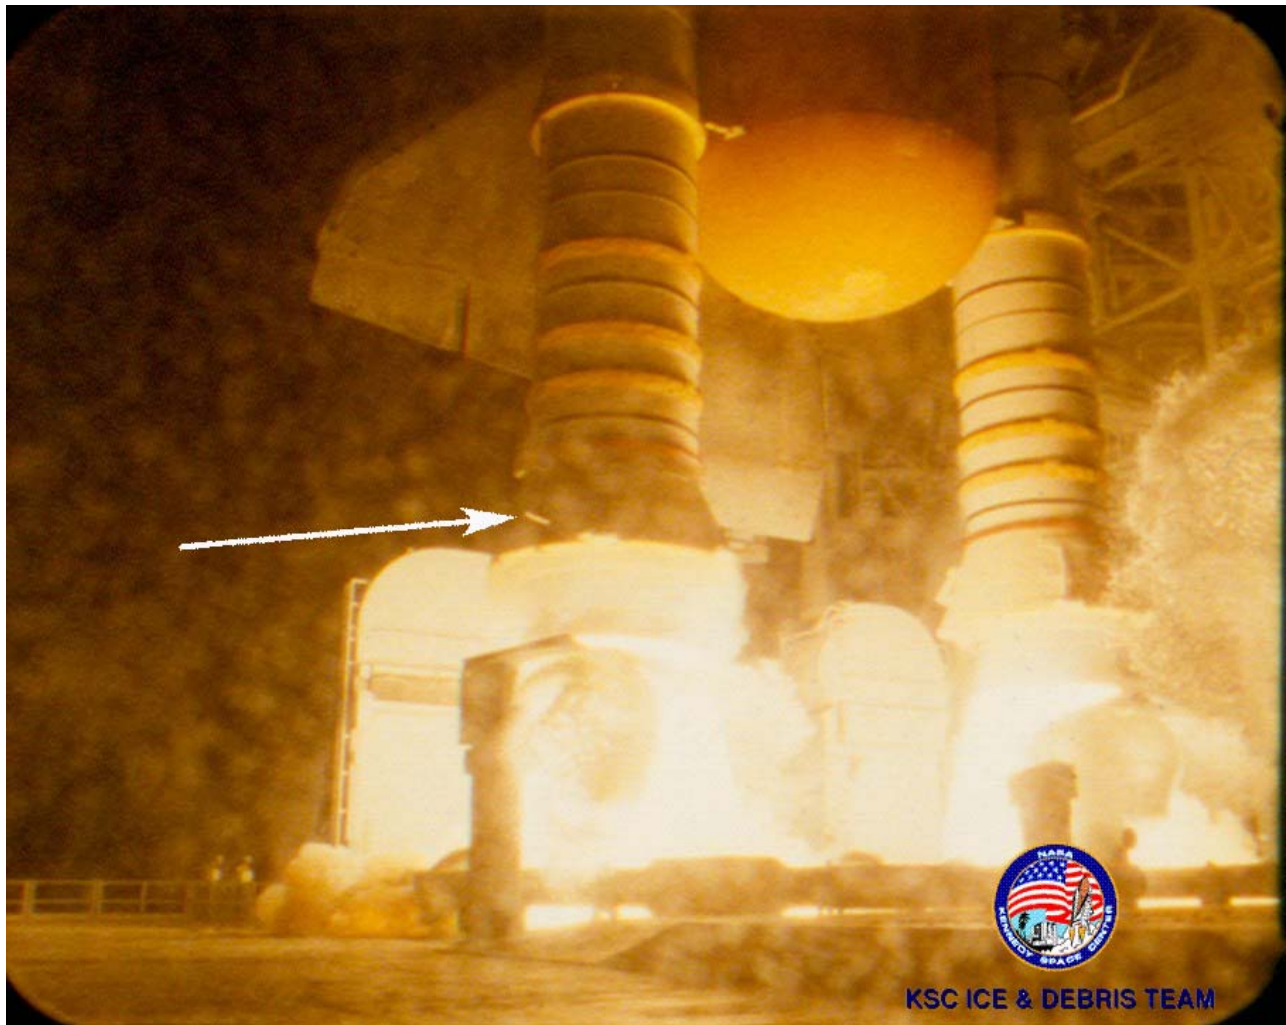
Several pieces of debris ejected from SRB exhaust hole at T-0, including large portion of RTV silicone from SRB HDP base-band. There was no contact with the vehicle. (E-1, E-4, E-57, E-60, E-62) The debris appears to have come from the base of HDP #3. (See photo #2) Clip showing debris ejected out of SRB exhaust hole:

Photo 2. Photo 2. Film item E-1. Debris emanating from SRB exhaust hole.
